**Flood Control Project Maintenance  
Levee Inspections**

**Fall 2010 Levee Maintenance Deficiency Summary Report**

**Levee District No. 0001 (Sutter County)**

**Levee Inspection Report By Mile - Fall 2010**

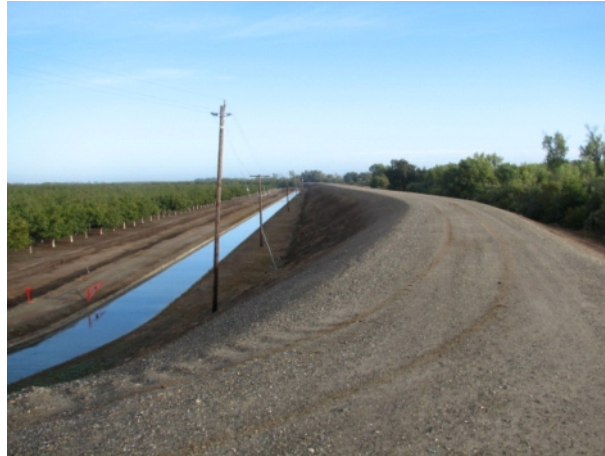
Levee Mile Report Line	1
Start Levee Mile	0.00
End Levee Mile	16.65
Location	Land Side
Category	Earthen Levee
Item	Vegetation
Levee mile 0.00, vegetation land side.	
cathom_f_20101027_174.jpg

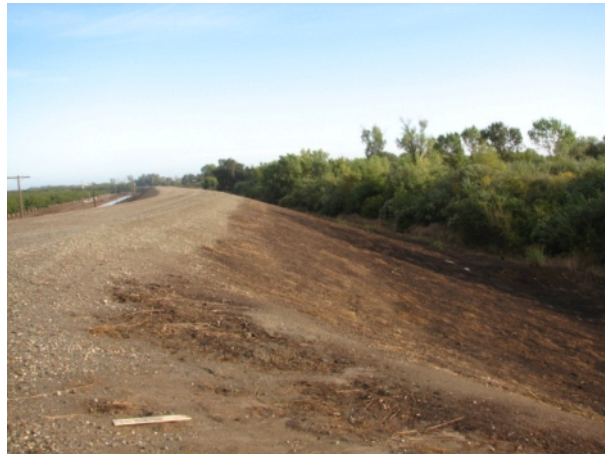
Levee Mile Report Line	2
Start Levee Mile	0.00
End Levee Mile	16.65
Location	Water Side
Category	Earthen Levee
Item	Vegetation
Levee mile 0.00, vegetation on water side slope.	
cathom_f_20101027_173.jpg

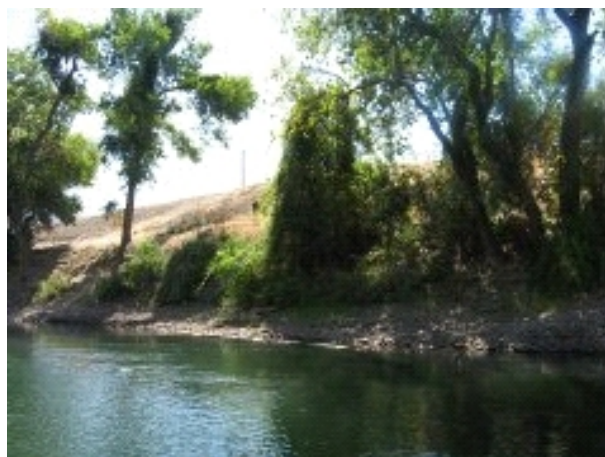
Levee Mile Report Line	5
Start Levee Mile	14.03
End Levee Mile	14.25
Location	Water Side
Category	Supplemental
Item	USACE Erosion Survey
2009: no berm, 1:1 slope, tree hazards, holes, seepage, clays and silts, 4.03 ft/s [2009 SiteID:FHR_28-5_R]	
cathom_f_20100928_001.JPG
